# Investigation on Performance of Jia Bharali River Bank Protection Measure Using Geotextile Bags

**Abstract**— River bank erosion is one of the major natural disasters being faced by the state of Assam, located in the North-eastern part of India. With the increasing popularity of geotextile materials in construction industry several pilot projects to control bank erosion of major rivers of Assam have recently been executed with the application of geotextile bags, geotextile tubes. But very little scientific study on the post-construction performance of these works is available. In this paper the findings of a study on the post construction performance of one of these recently completed bank protection works is presented. In order to ascertain the erodibility of the bank soil characterisation of geotechnical properties of the bank soil is carried out. The bore log obtained by adopting a simplified method of boring suitable for this investigation is presented along with detailed laboratory test results and analysis. The change in river flow pattern near the bank after installation of the bank protection work and the resultant siltation is studied in this work. In order to predict p

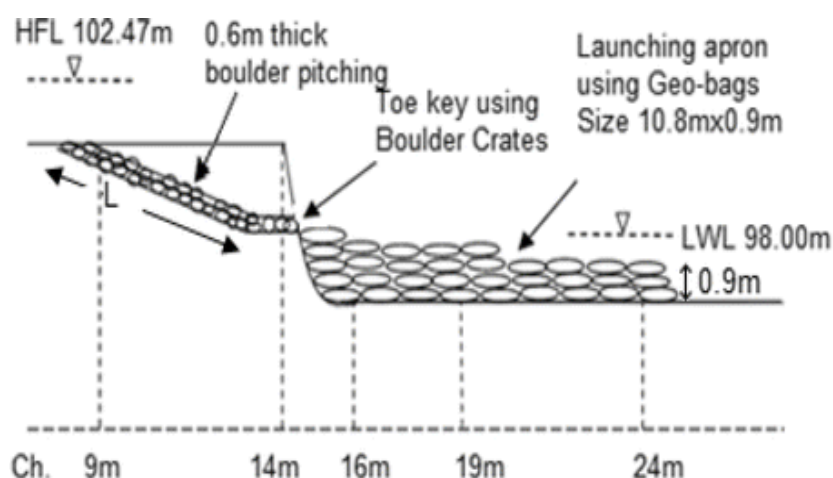
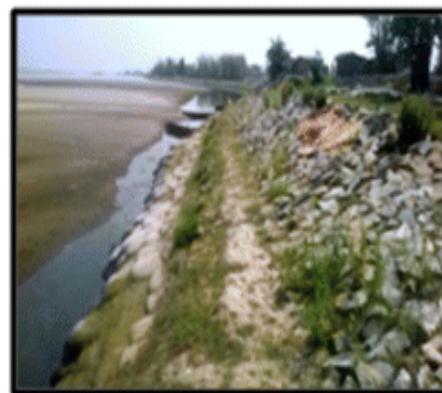
**FIGURE 3: TECHNICAL DETAILS OF THE BANK PROTECTION WORK INSTALLED BY WATER RESOURCES DEPARTMENT ASSAM**

The detail of the protection work designed and installed at the river bank by the Water Resources Department (WRD) is shown in Fig. 3 and Table 2.

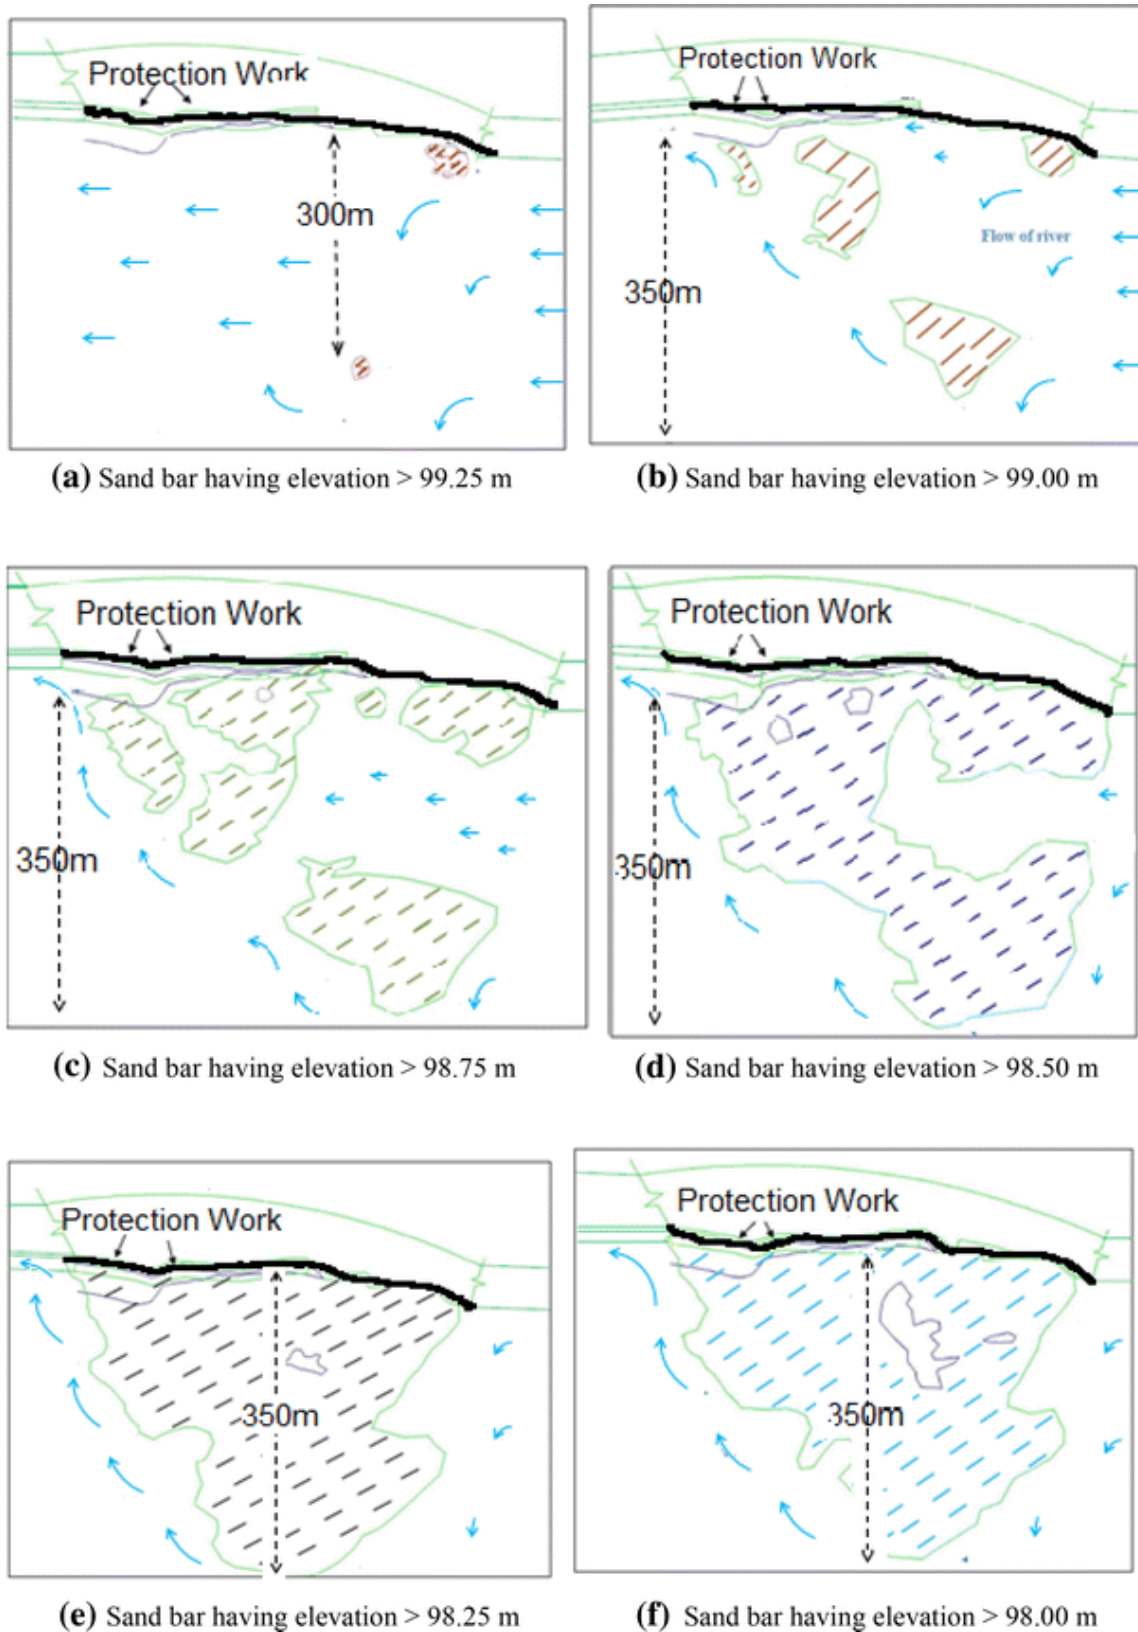
FIGURE. 5

SAND BAR HAVING ELEVATION A  $>99.25$  M; B  $>99.00$  M; C  $>98.75$  M; D  $>98.50$  M; E  $>98.25$  M; F  $>98.00$  M

As the speed of stream is diminished after establishment of the bed cook's garment the primary indication of siltation is seen close to the upstream end of the bed smock (Fig. 5a). Figure 5a likewise demonstrates start of mid-channel siltation at an area around 300 m far from the bank showing redirection of the waterway stream bearing far from the insurance work. As the surge water retreats the siltation territory develops around the underlying mid-channel sand bar and furthermore close to the downstream side of the starting smock (Fig. 5b-d). It demonstrates progressive redirection of the waterway water stream channel far from the bank. Figure 5 demonstrates that the zone of impact of the bed assurance work through propelling overskirt stretches out up to remove 350 m from the bank into the stream which is about 30 times that of the 10.5 m width of the starting cover.

Figure 5e, f demonstrates that in spite of the fact that the starting smock effectively redirected the stream water stream channel far from the bank close to the upstream end of the insurance measure and brought about advancement of another sand bars no siltation happens quickly past the downstream end of the assurance measure and the waterway channel returns strongly towards the bank just past the downstream end of the bed cook's garment. Since the bank soil is erodible, as obvious from the geotechnical testing, this sharp stream of the waterway towards the bank downstream of the security work has made it profoundly powerless against impinging stream disintegration.

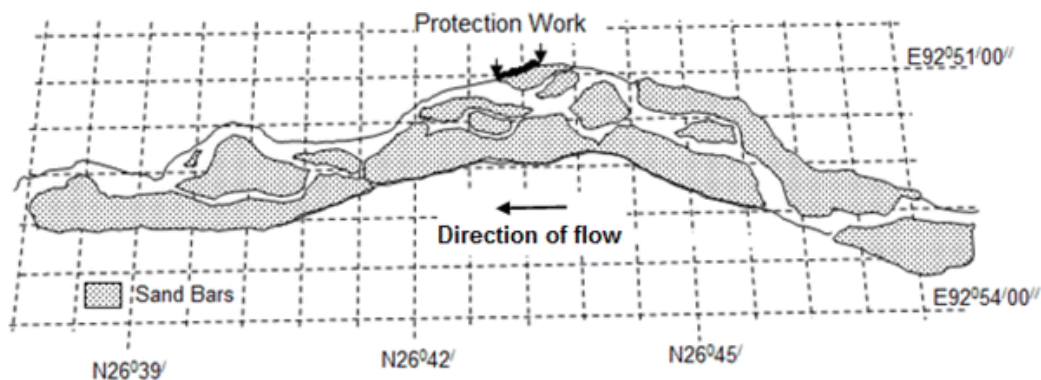
(a) Flow pattern and sand bars of Jia Bharali river in the study area as on March 2015

Figure 6 plainly demonstrates that the waterway channel has strongly returned into the bank. This channel has begun new bank disintegration in the prompt downstream of the insurance work.

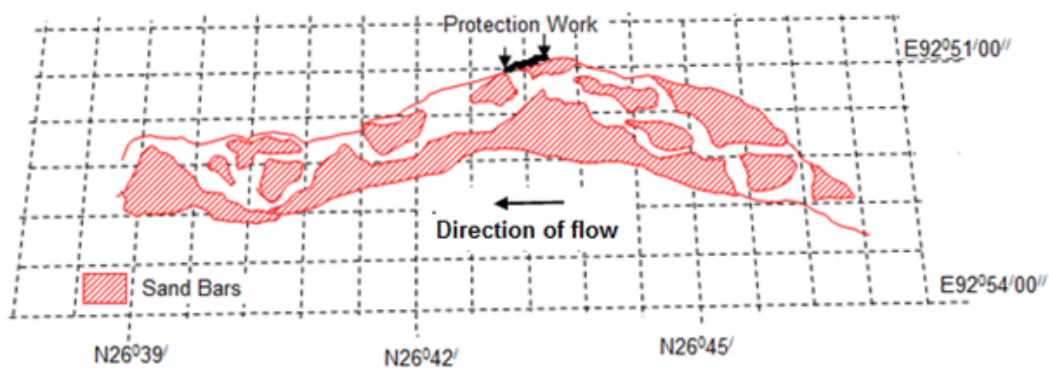
(b) Flow pattern and sand bars of Jia Bharali river in the study area as on March 2013

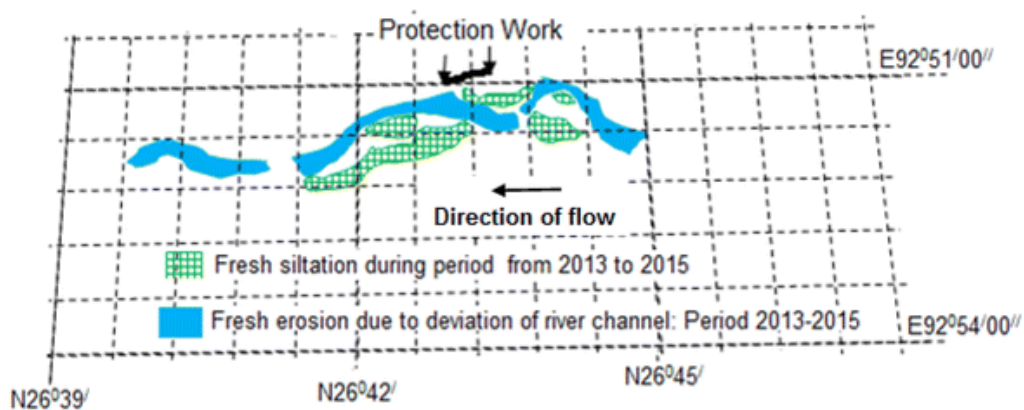
(c) Fresh change in flow direction and siltation areas during the period from 2013 to 2015

Jia Bharali stream, after establishment of the assurance measure in the western bank, has logically come nearer to a similar bank in the downstream of the security work. It, consequently, has additionally expanded the powerlessness of the bank to disintegration in quick downstream of the security measure. In this downstream segment of the stream, amid the time of 2 years from 2013 to 2015, the waterway has changed course towards the western bank bringing about bank disintegration and arrangement of mid-channel sand bars. This has made an earnest need to ensure the waterway bank facilitate downstream of the assurance work under review.

zone of a similar bank. Such venture arranging needs to incorporate measures to lessen downstream bank disintegration especially if the geotechnical properties of the bank soil in the downstream extend are observed to be poor.
