# Science and Engineering Technology: Railway Engineers' Moral Responsibilities for Passenger's Safety Travel

Satya Sundar Sethy

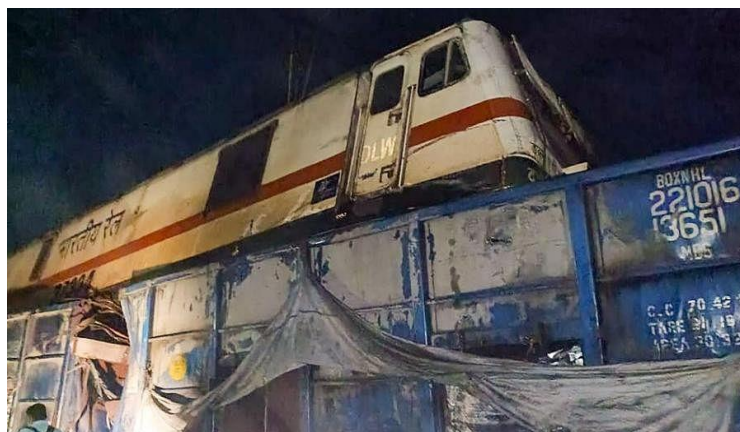
**IMAGE 1: The Express train engine jumped onto the freight train wagons**

The Coromandel Express (Train No 12841) run on the up-track. The train was scheduled to travel from Howrah station to Chennai station. The Yeshwantpur-Howrah Express (Train No 12864) was running on the down-track and was scheduled to go from Yeshwantpur station to Howrah station. These two trains were passing each other at the Bahanaga Bazar station, where there was no stop for these trains. Hence, they were running within their speed limit on their respective tracks as per Indian railway manual guidelines. A freight train carrying iron ore was parked on the loop line of the up-track at Bahanaga Bazar station, allowing these two trains to run on their respective tracks and maintain their scheduled arrival time at the next station. A green signal was given to the Coromandel Express train to veer its route to the loop line of the up tracks, where a freight train was already parked. Therefore, the Coromandel Express train diverted its route to the loop line of up-track and crashed into the freight train. As a result, its engine jumped onto the parked freight train waggons, its derailed bogies were made upside down and rammed into one another, and some of its bogies were thrown to the opposite track where the Yeshwantpur-Howrah

Express train was passing by. When the Coromandel Express train derailed bogies crashed into the Yeshwantpur-Howrah Express train's rear bogies, some of the Yeshwantpur-Howrah Express train bogies were derailed, made upside down, and rammed into Coromandel Express bogies. About sixteen bogies of both trains derailed and collided with each other. This caused the major triple-train disaster in India in June 2023.

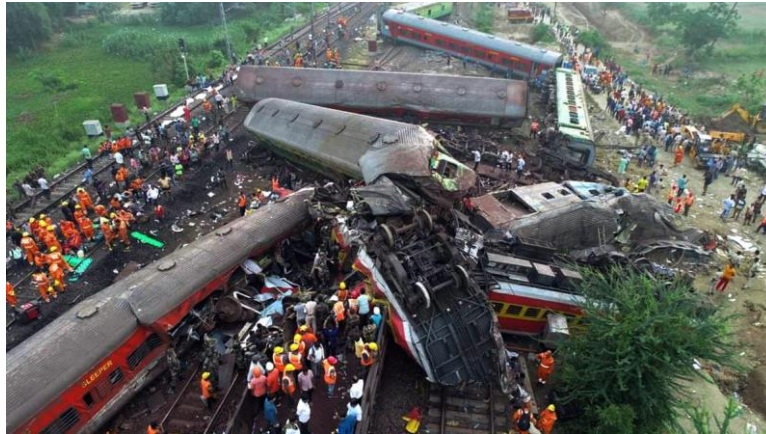
**IMAGE 2: Aftermath of the accident in Odisha, India**

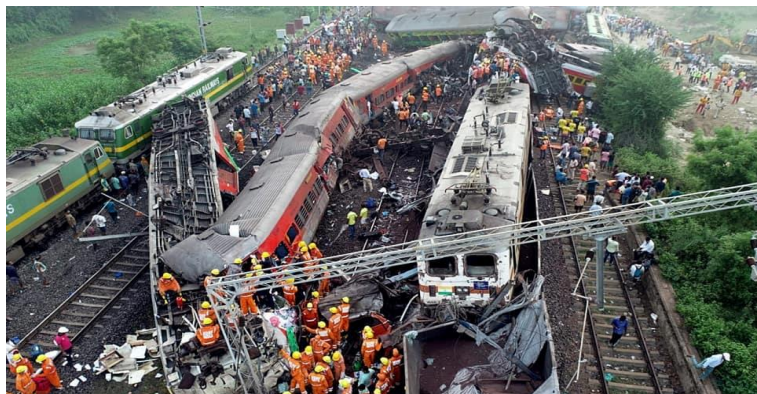
**IMAGE 3: Accident site in Odisha, India**
