# The influence of the environment factors and the surface treatment on Stress Corrosion Cracking of Type 304 Austenitic Stainless Steel

**Abstract**— The aim of this work is to understand the combined effects of stress, temperature, humidity and chloride ion on the susceptibility of stress corrosion cracking (SCC) of type 304 austenitic stainless steel. The occurrence of SCC was investigated using the as received (cold work), sensitized samples those are exposed in the environmental test chamber at 40°C and 70°C, respectively. The humidity from 40% to 70% RH with gradient of 10% was applied during the corrosion test lasted 720h. The results showed the environmental conditions where SCC crack can be occurred and where it can be avoided. The initiation and the propagating of SCC crack on the flat and U-bend specimens were grown up to correspond to the increasing of test temperature. Very high stress cracking can be observed in the period of low relative humidity (40%) and temperature (40°C).

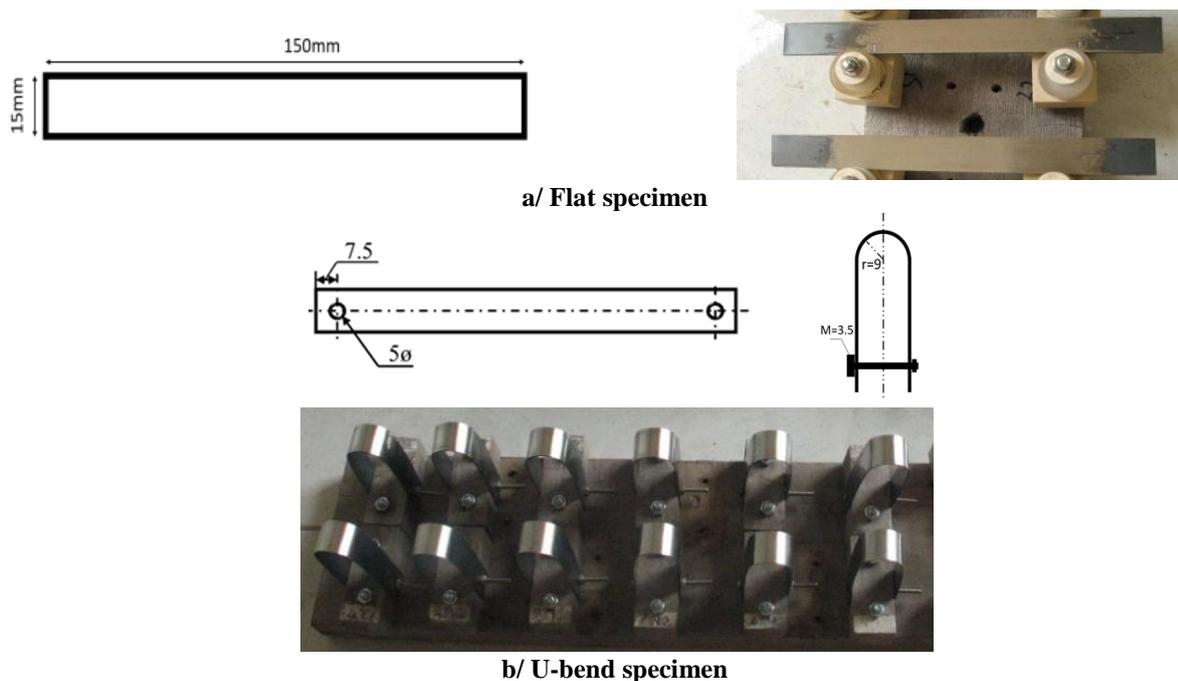
**FIGURE 1. Flat (a) and U-bend (b) specimens**

Type 304 austenitic stainless steels (0.065C, 0.58Si, 1.9Mn, 0.014P, 0.022S, 8.789Ni, 18.56Cr, %mass, Fe: bal) with thickness of 0.8mm was cut into 15mm x150mm as the samples. The tests were carried out using the flat and U-bend specimens fabricated from the above steel (Fig.1).

The testing samples were kept in the condition of “as - received (cold-worked)” and “sensitized”. For the sensitized condition, the samples were treated at 700°C for 2 hours, after that, they were cooled down slowly in the air. U-bend specimens were prepared according to ASTM G30-97 [10].

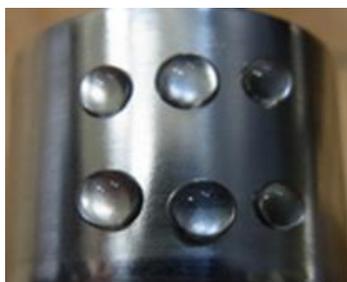
**FIGURE 2.U-bend specimen with freshly deposited droplets**

Both flat and U-bend samples were dropped with six droplets of chloride solution as shown in Fig.2. For the U-bend samples, two big drops were deposited on the top area and four smaller ones on the side area.

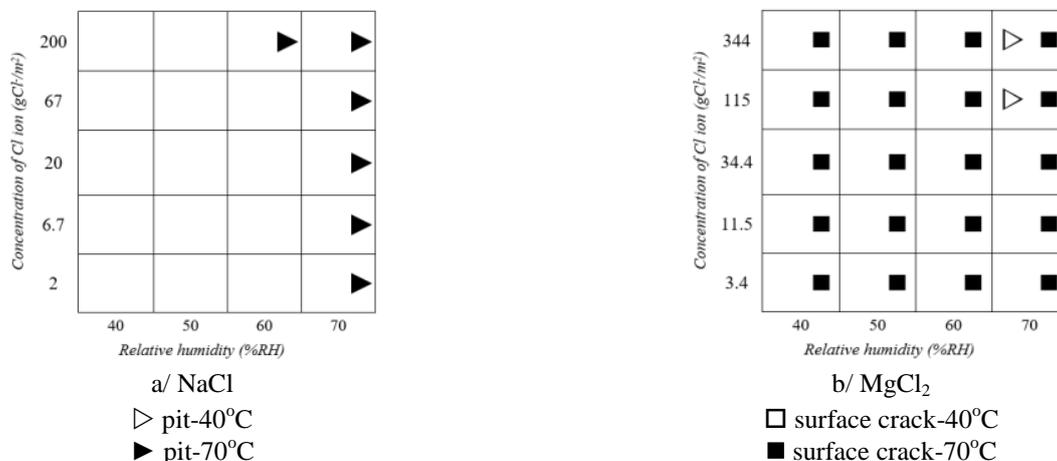
**FIGURE 3. The corrosion behavior of the as-received flat samples deposited with saturated NaCl droplets (a) and MgCl<sub>2</sub> droplets (b)**

All samples deposited with various concentration of chloride ions were exposed in the environment chamber at 40°C and 70°C which combined with four different levels of 40%, 50%, 60% and 70%RH. The tests were terminated after 30 days exposed. The results for type 304 as-received flat samples are presented in Fig 3.

It is recognized that concentrated NaCl solutions were not severe enough for SCC occurred on the type 304 as-received flat samples at 40°C. Even at the high temperature (70°C), only pitting was observed at 70%RH (Fig.3.a).

For the MgCl<sub>2</sub> deposited samples, almost no failure occurred at 40°C, but only pitting corrosion appeared at 70%RH on the samples deposited with high chloride levels – saturated and three times diluted. (Fig.3b and 4a). At 70°C, the cracks appeared on all the samples, irrespective of values of relative humidity and concentration of chloride ion, the pit size was larger and the cracks initiated from the pits were observed (Fig. 3b and Fig. 4b). The above results can be explained as follows: The chloride amount in one droplet of MgCl<sub>2</sub> solution is always higher than that in one droplet of NaCl solution, in addition, MgCl<sub>2</sub> solution is acidic (with pH = 5.7), which accelerated the metallic soluble react. Because MgCl<sub>2</sub> deliquesced at lower

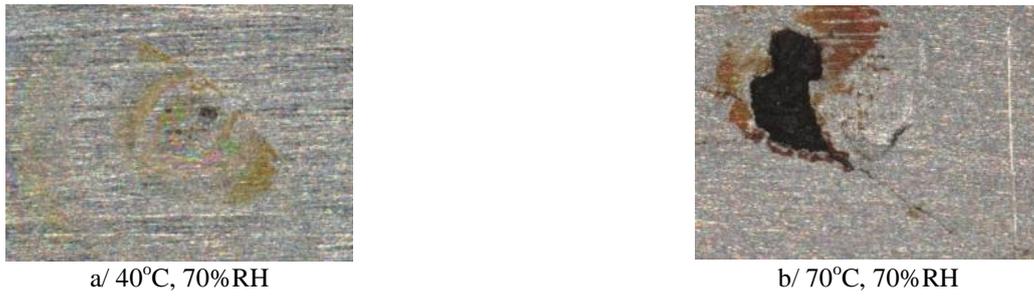
**FIGURE 4. The appearance of the as-received flat samples with saturated MgCl<sub>2</sub> droplets after 30 days, (160x)**

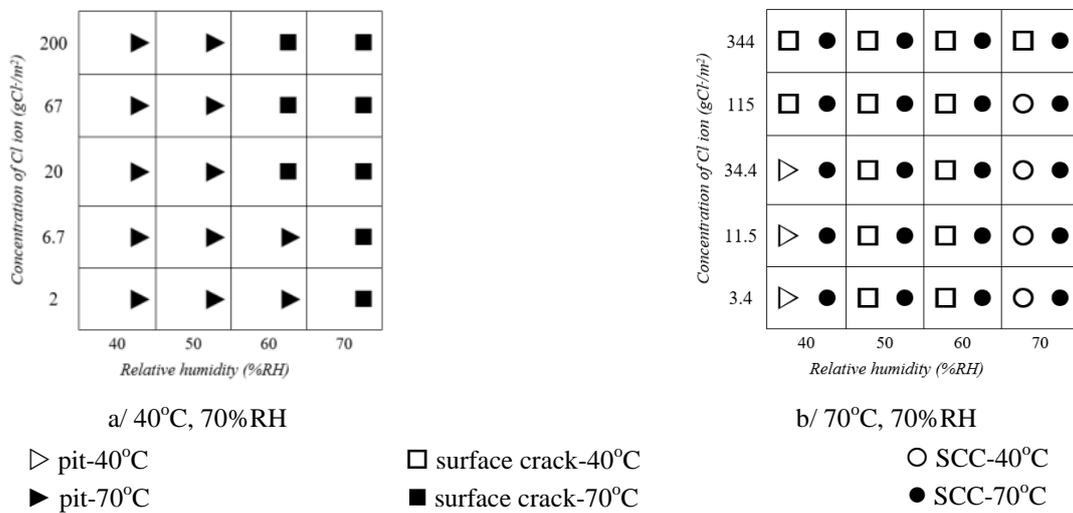
**FIGURE 5. The corrosion behavior of the sensitized flat samples with NaCl droplets (a) and MgCl<sub>2</sub> droplets (b)**

The results of testing the sensitized flat specimens are given in Fig. 5, which shows higher SCC susceptibility than that of the as-received specimens due to depletion of Cr in the area near the grain boundary

With regard to the sensitized flat samples deposited with MgCl<sub>2</sub>, the pits and shallow SCC crack were observed more severely than those dropped with NaCl, which is indicated by the larger SCC cracking size (Fig. 5.b). The pits and the surface cracks were found right at low temperature (40°C) and low RH (40, 50, and 60%). By means of the increasing temperature and RH, the SCC initiated and the number of crack as well as the crack length becomes greater.

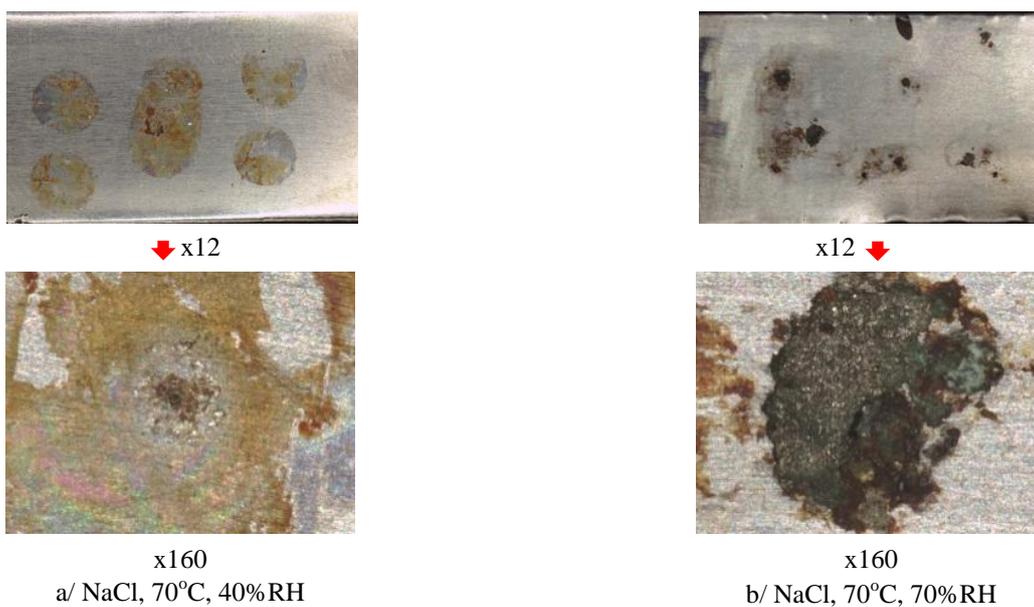
**FIGURE 6. The appearance of the sensitized flat samples with saturated solution NaCl droplets**

Similar to the as-received samples, the NaCl droplets does not cause SCC of the material at 40°C; however, at the higher temperature (70°C), the pits were formed on the surface of all the samples tested at 40% and 50%RH. At 60%RH, the surface crack was observed on the samples deposited with NaCl of at least 20gCl/m<sup>2</sup>. At 70%RH, the SCC cracks appeared on all samples tested at every NaCl concentration. Therefore, NaCl is easier deliquesced at higher RH, which accelerated the metallic soluble react at the crack tip and promoted the cracks appeared. The increase of temperature and Cl<sup>-</sup> content also showed the similar promotion as the above.

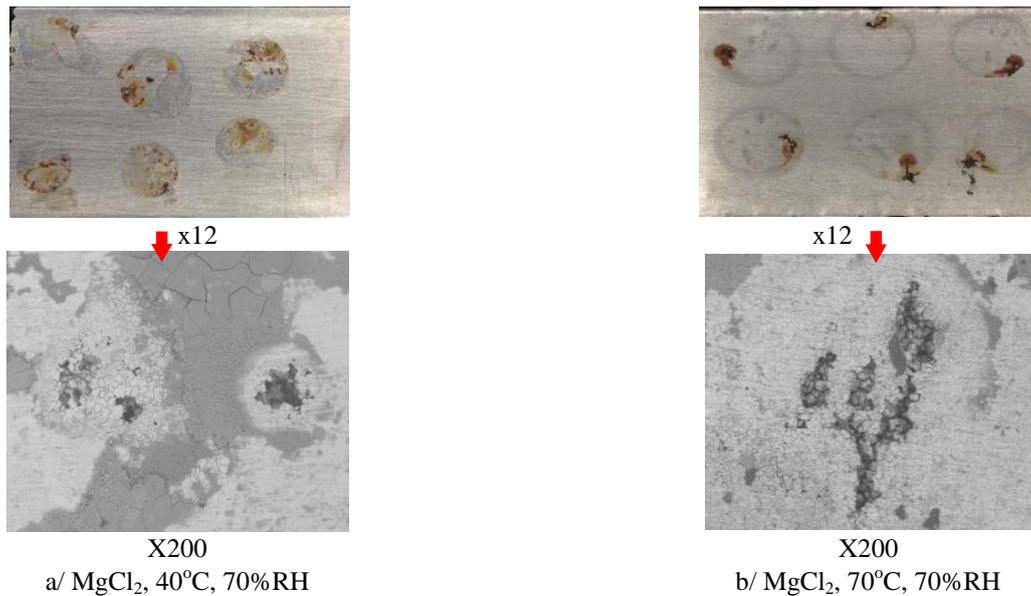
**FIGURE 7. The appearance of the sensitized flat samples with saturated solution of MgCl<sub>2</sub> droplets**

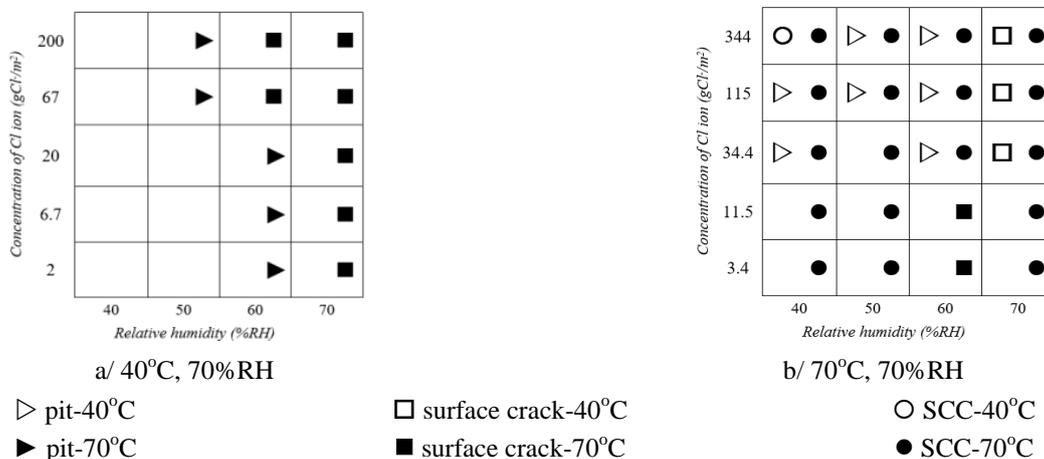
Following the flat sample trials, the U-bend samples were tested in the same conditions with those applied to the flat samples. The corrosion behaviors of the as-received U-bend samples are expressed in Fig. 8.

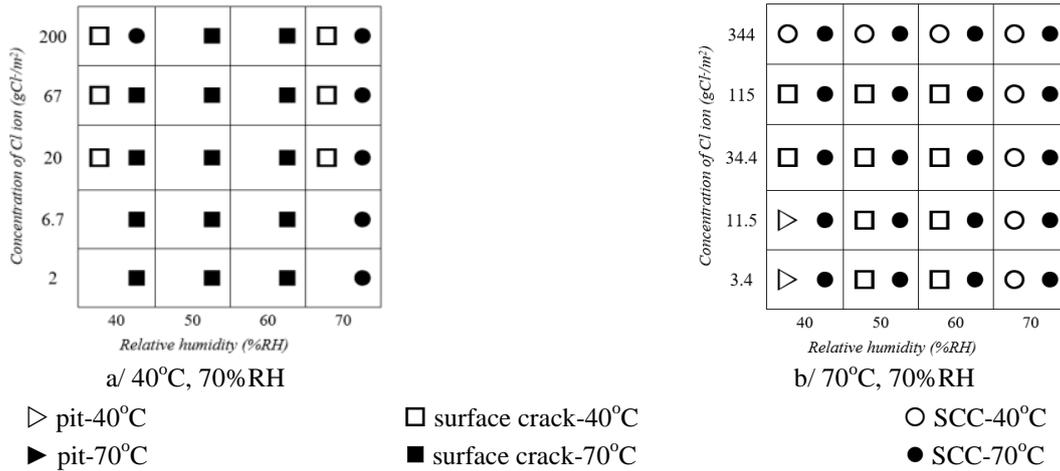
**FIGURE 12. The corrosion behavior of the sensitized U-bend samples with NaCl droplets (a) and MgCl<sub>2</sub> droplets (b)**

The results of testing the sensitized U-bend samples are shown on Fig. 12. For the specimens dropped with NaCl and tested at 40°C, the surface cracks were found at 40% and 70% RH when the minimum of chloride ion level is  $\geq 20$  gCl<sup>-</sup>/m<sup>2</sup>.

In the experiments of U-bend specimens with MgCl<sub>2</sub> droplets, the SCC-accelerated was not controlled by the humidity of environment. The main factors which influence SCC were the temperature and concentration of chloride ions (Fig. 12.b).

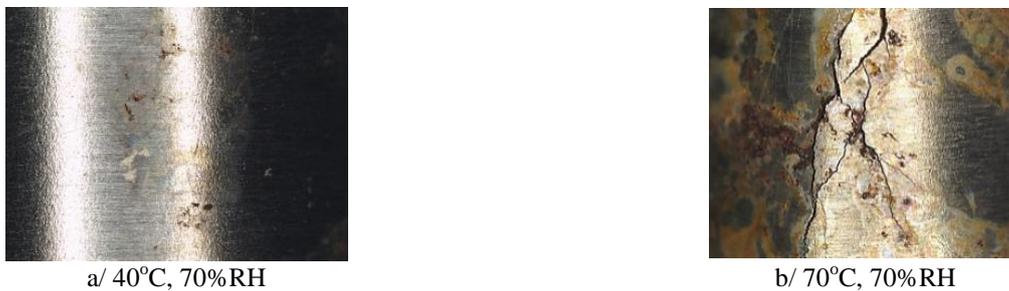
**FIGURE 13. The appearance of the sensitized U-bend samples with saturated solution of NaCl droplets (12x)**

Under condition of higher temperature (70°C), the surface crack was observed on all the specimens tested at 40, 50 and 60%RH without distinction of concentration of chloride ions. Furthermore, when the RH increased, the SCC crack was found to propagate and the secondary crack was very easily detected (Fig.13).

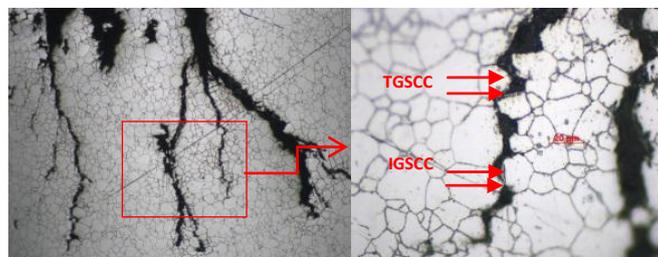
**FIGURE 14. Morphology of the crack on U-bend sample 304 (MgCl<sub>2</sub> saturated solution, 40% of RH and 40°C)**

pitson the sensitized specimens exposed to  $MgCl_2$  at low RH (40% and 50% of RH). The crack often propagated by the inter-granular and trans- granular path (Fig. 14b.).

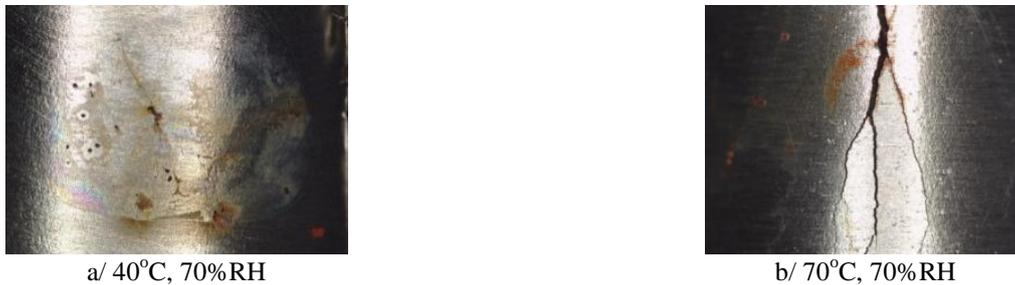
**FIGURE 15.**The appearance of the sensitized U-bend samples with saturated solution of  $MgCl_2$  droplets (12x)

Finally, at 70°C, the SCC cracks were observed on all of specimens. And the samples were broken clearly due to the high level of relative humidity, and chloride concentration (Fig.15).
