# Analysis of the Plate Heat Exchanger Failure

**Abstract**— The present article describes the effect of the pressure on the operability of the plate exchanger of the SWEEP IC 5 x 20 type as well as the results of the numerical analysis of the stresses at three different loads. The exchanger was tested at the testing pressure defined by the manufacturer (2 MPa). Maximum stresses were observed at the places of soldered joints on individual exchanger plates and the stress was highly above the carrying capacity of the solder joint. With an increasing distance from the place where the boards were connected, stress exhibited a sharp increase. The testing was also focused on the stresses on the surface area (shroud) of the exchanger at the permissible operating pressure of 1.6 MPa defined by the manufacturer. An important observation was the stress identified at the measured real operating pressure of 0.7 MPa –destruction of the exchanger used by the operator.

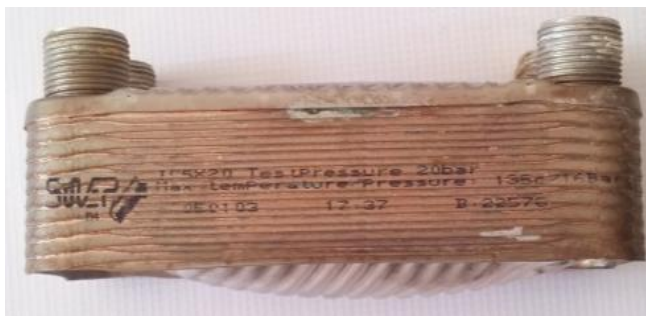
FIGURE 1: Deformation of the outer wall of the exchanger

The calculation was made using the maximum testing pressure defined by the manufacturer, i.e., 2.0 MPa, and the permissible operating pressure, i.e., 1.6 MPa. Subsequently, the exchanger was tested for the condition corresponding to the real plastic deformation of the front external wall of the exchanger (Fig. 1). This deformation was identified on the basis of the measurement of the deformed exchanger and represented the value of 10.5 mm. It was detected by the operator during the real operation of the exchanger at the pressure of 0.7 MPa.

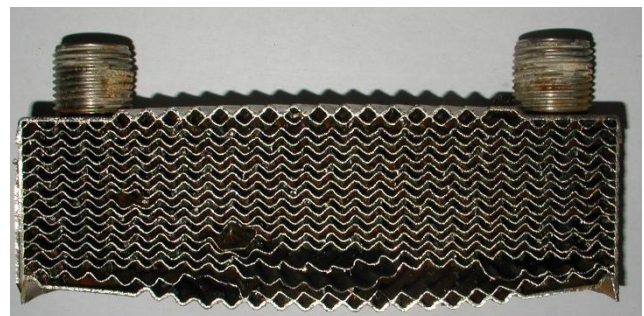
FIGURE 2: Deformation of the soldered joints of boards

The outer smoother plate (shroud) of the analysed plate heat exchanger was 1.3 mm thick. This parameter of the exchanger plate was measured after the destruction thereof during the operation (Fig. 2). The inner profiled heat-transfer surface of the plate was 0.43 mm thick. The values required for the identification of an increase in the pressure in the distribution system were obtained by measuring the volumetric flow rate of water in the heat distribution system  $Q_V$  and subsequent analytical calculations. Table 1 contains the parameters corresponding to the water with the temperature of 55 °C.

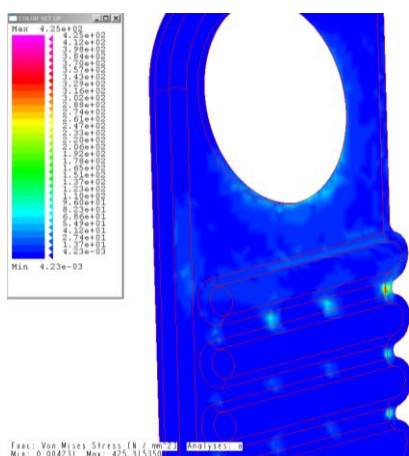
At the *testing* pressure of 2 MPa, maximum stresses were formed at the points of soldered joints on individual exchanger plates. As the distance from the plate joints increased, the stress sharply increased as well. At the given pressure, the peak stress  $\sigma$  reached the value of as much as 425 MPa (Fig. 3).

**FIGURE 3: Detail of the stress distribution in soldered joints ( $p = 2$  MPa)**

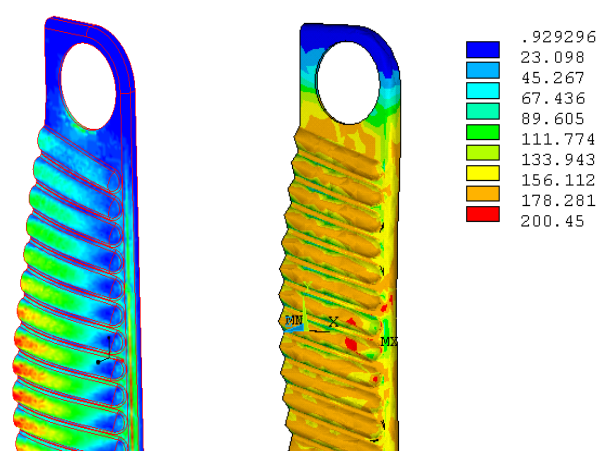
**FIGURE 5: Stress distribution on the external wall ( $p = 0.7$  MPa)**

At the *measured* operating pressure of 0.7 MPa, the stress was observed in the area of the non-linear statics. For the available solders, the distribution of the yield stress values ranged from  $\text{Re} = 170 \text{ MPa}$  to  $\text{Re} = 1,030 \text{ MPa}$ . Due to unknown physical properties of the used solder, the calculation of the yield stress was made on the basis of the known deformation of the exchanger wall representing 10.5 mm. The approximation method of calculation, with the known value of the deformation of the exchanger front plate, the corresponding value of the yield strength was identified as 178 MPa. This value was affected by the number of kinematic reinforcements. The given value of the yield strength corresponds to the NICOLOY 800HT solder material. With this material and at the pressure of 0.7 MPa, the stresses in the top plate of the exchanger are shown in Fig. 5. The maximum stress  $\sigma$  on the exchanger plate achieved the value of 200 MPa.
